# SHORELINE MODIFICATION & CLIMATE CHANGE COWICHAN VALLEY, BRITISH COLUMBIA

Implications to communities, natural systems and salmon

Prepared by Resilient Coasts for Salmon

April 2026

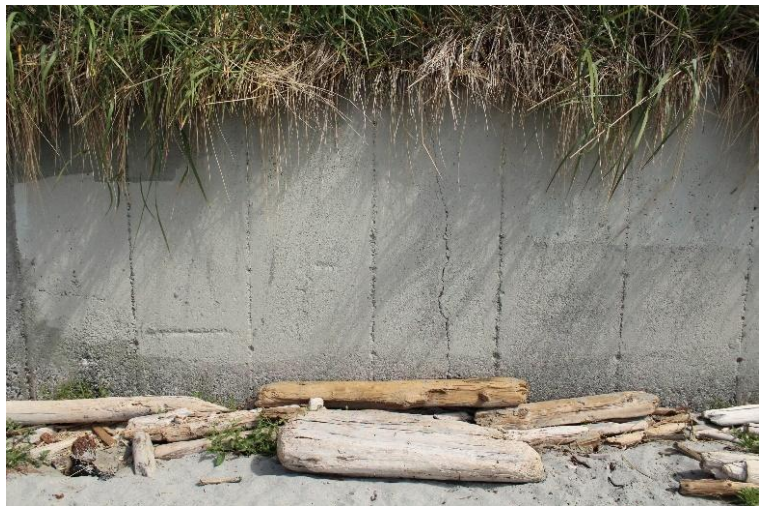
Figure 5 - An example of a seawall (one type of shoreline modification). Photo by Maria Catanzaro.

Hard armour refers to structures like **concrete seawalls or rock riprap that are installed to armour shores and the infrastructure behind them from incoming waves (Figure 5)**. The construction of shoreline armour has led to a false sense of security and an associated rise in populations in flood prone areas (Rumson et al., 2017). In British Columbia, there are no provincial regulations preventing landowners from constructing shoreline armoring up to the mean high-tide line, which can have negative implications for forage fish and other coastal species (Buchanan et al., 2019). Seawalls also support 23% lower biodiversity and 45% fewer organisms than natural shorelines (Gittman et al., 2016). Local governments have some power here to impose community policies and bylaws to prevent further armoring from being constructed and protecting shoreline habitat. We are hopeful that the new [B.C.](#)

[Coastal Marine Strategy](#) this will lead to provincial legislative protection of B.C. shorelines. Hard armoring on shorelines can exacerbate erosion by waves scouring the base of the structure over time, causing structures to crack overtime. Natural sediment transfer (replenishment), a natural process along coastlines, is disrupted when modifications exist. Combined with sea level rise, the shoreline's ability of adapting to sea level rise over time will be disrupted where structures exist. While hard armour is very common on shorelines, there are other types of coastal modifications, including overwater structures, which have impacts on the coastal environment.

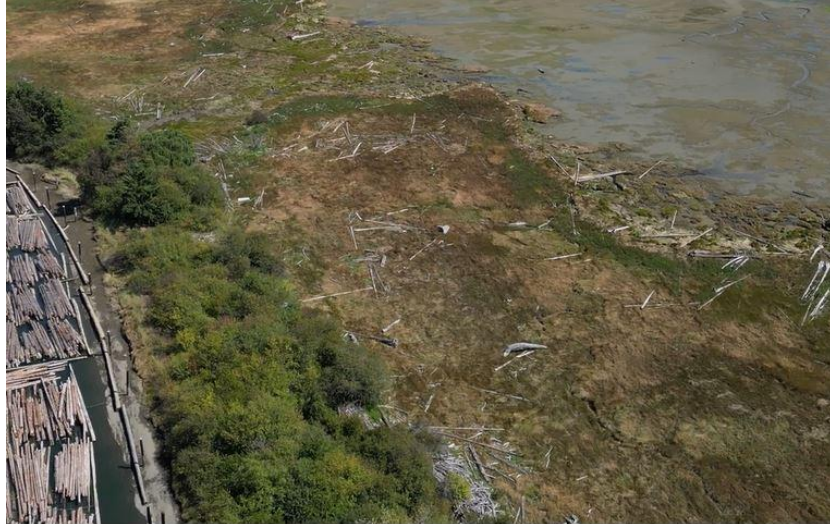
Figure 6 - A high/extreme accumulation of logs on an estuary marsh shoreline in Cowichan Bay, where the majority of the accumulated logs are processed logs from the forestry industry. Photo by Michael Miller Media (Resilient Coasts for Salmon imagery).

Log accumulations on beaches is a concern due to their potential to **impact coastal habitat for forage fish.** The logs that are predominantly found washed up on beaches are from the logging industry. This means that they have been processed in some way: most have had their ends cut with branches and bark removed, and some have been further treated with preservative agents.

While **natural logs with root wads can be remarkable shoreline restoration tools to help accumulate and secure sediment, their processed counterparts can have very negative impacts on shoreline habitats.** Without branches or root wads, they can easily roll over beaches, crushing any creatures that might be living there including forage fish eggs. Logs can also impact the biotic communities of rocky shorelines. A recent study showed that populations of key foundational intertidal species such as the thatched barnacle were 20–80% lower on rocky intertidal areas where there was abrasion from logs, compared to adjacent areas that were protected from the abrasion (Pérez Andresen et al., 2025). An accumulation of logs can also smother vegetation on the shoreline (Figure 6). When this is combined with coastal modification, those logs may continue to be mobile since they cannot settle higher in the backshore, exacerbating the impacts of erosion on those beaches, and potentially degrading the structures themselves. These impacts can be exacerbated by increasingly frequent and intense storms.

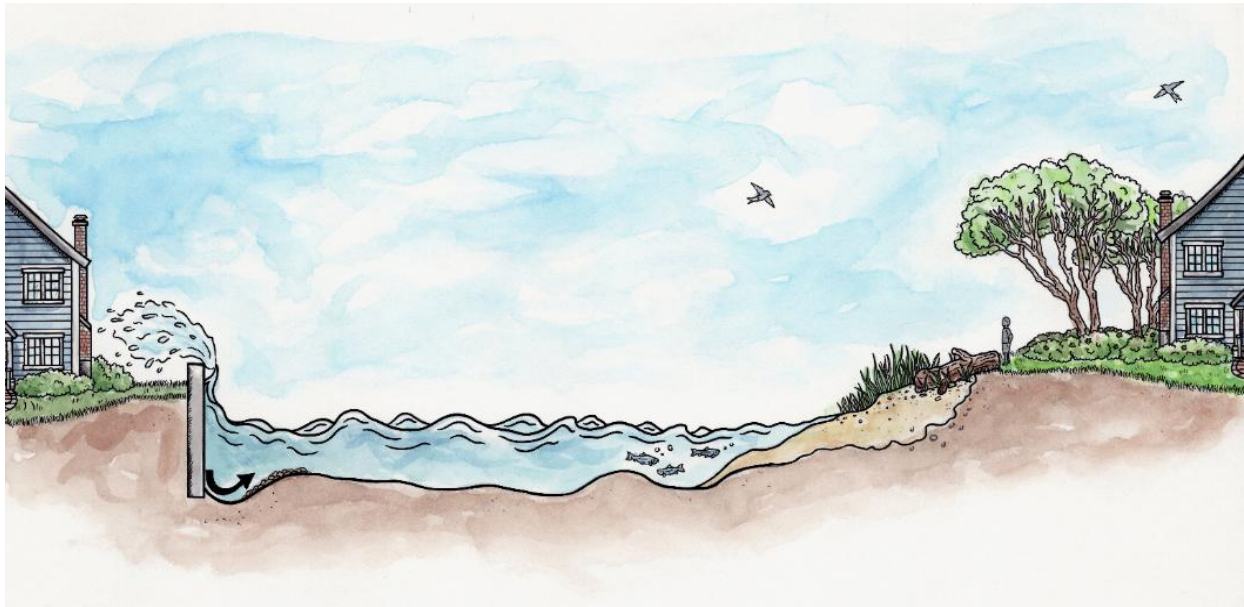
Figure 9 - A comparison of an armoured shoreline (left) with a natural shoreline (right). Illustration by Holly Sullivan.

As mentioned, **human-made seawalls are static** (Figure 6, left side of the image) and offer little habitat value, can cause overtopping (waves splashing onto the property), and deflects wave energy, which causes erosion and impacts to adjacent areas. However, some **alternatives** to hard armoring are nature-based approaches to restoring shorelines. Restoring shorelines with soft shore (nature-based) approaches (Figure 9, right side of the image) encourages a more **diverse habitat** on the shore and intertidal zones. The **natural gradient tempers wave energy and can adjust dynamically as sea levels rise**. Overhanging tree branches and shrubs also benefit salmon by **providing shade and prey species**.

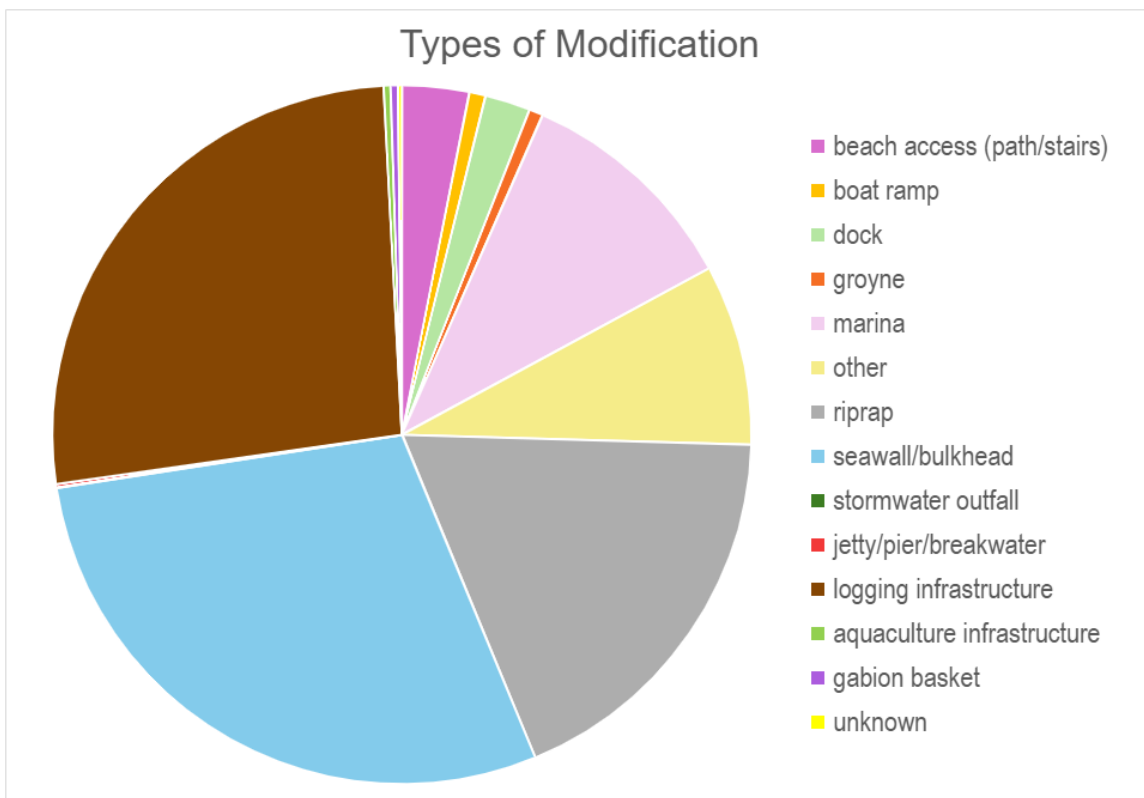
Figure 12 - The proportion of each type of modification found on modified shorelines of the Cowichan Valley, with seawall/bulkhead being the most common type, followed by logging infrastructure.

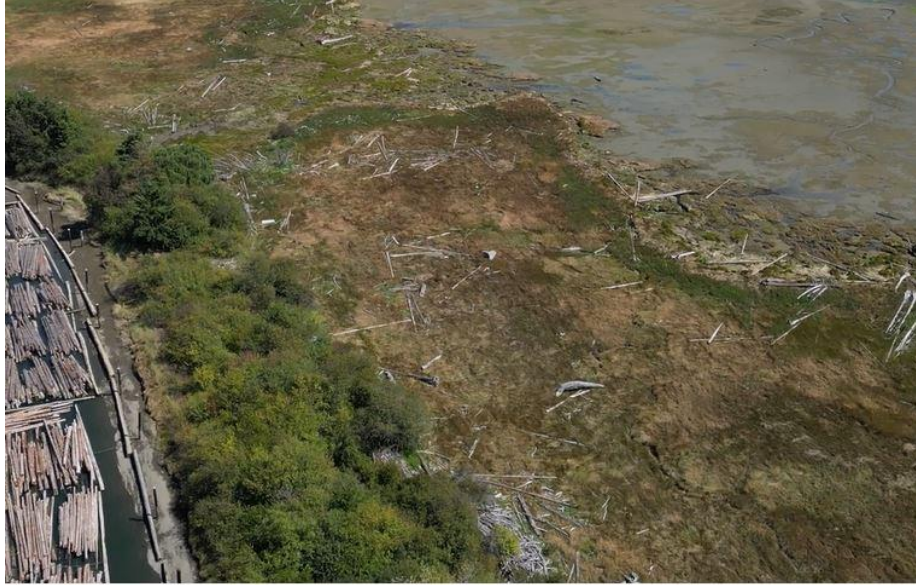
Figure 30 - Imagery from the Cowichan River Estuary, showing log accumulation of mostly processed logs on a marsh platform. Photo by Michael Miller Media (Resilient Coasts for Salmon imagery).

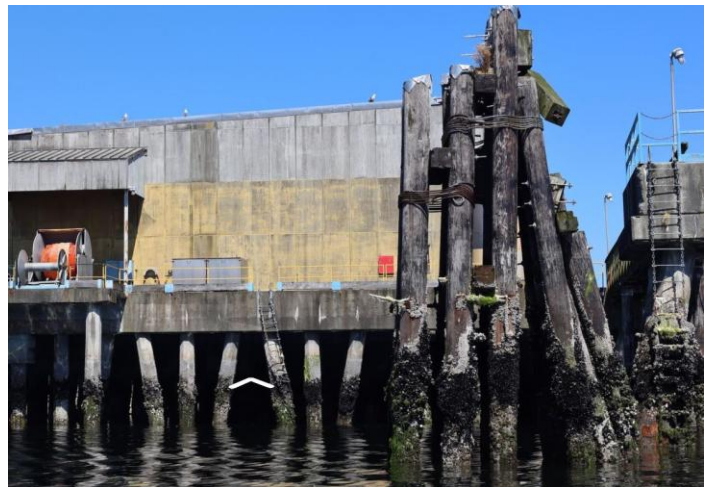
Figure 31 - Creosote pilings were often found as part of industrial overwater structures present in estuaries and the nearshore marine environment in the Cowichan Valley. Photo by Michael Miller Media (Resilient Coasts for Salmon imagery).

Often, logs treated with creosote (a preservative made from tar) can end up on beaches, or are present in the nearshore environment as pilings, which can have negative consequences for forage fish. Persistent chemicals such as PAH's found in creosote have negative impacts on marine organisms (Sibley et al., 2001). For forage fish species like Pacific herring whose eggs attach to surfaces like pilings and eelgrass in the nearshore environment, the presence of creosote pilings can sabotage a spawn event, decreasing the success of hatching in some and causing physical abnormalities in others (Vines et al., 2000).

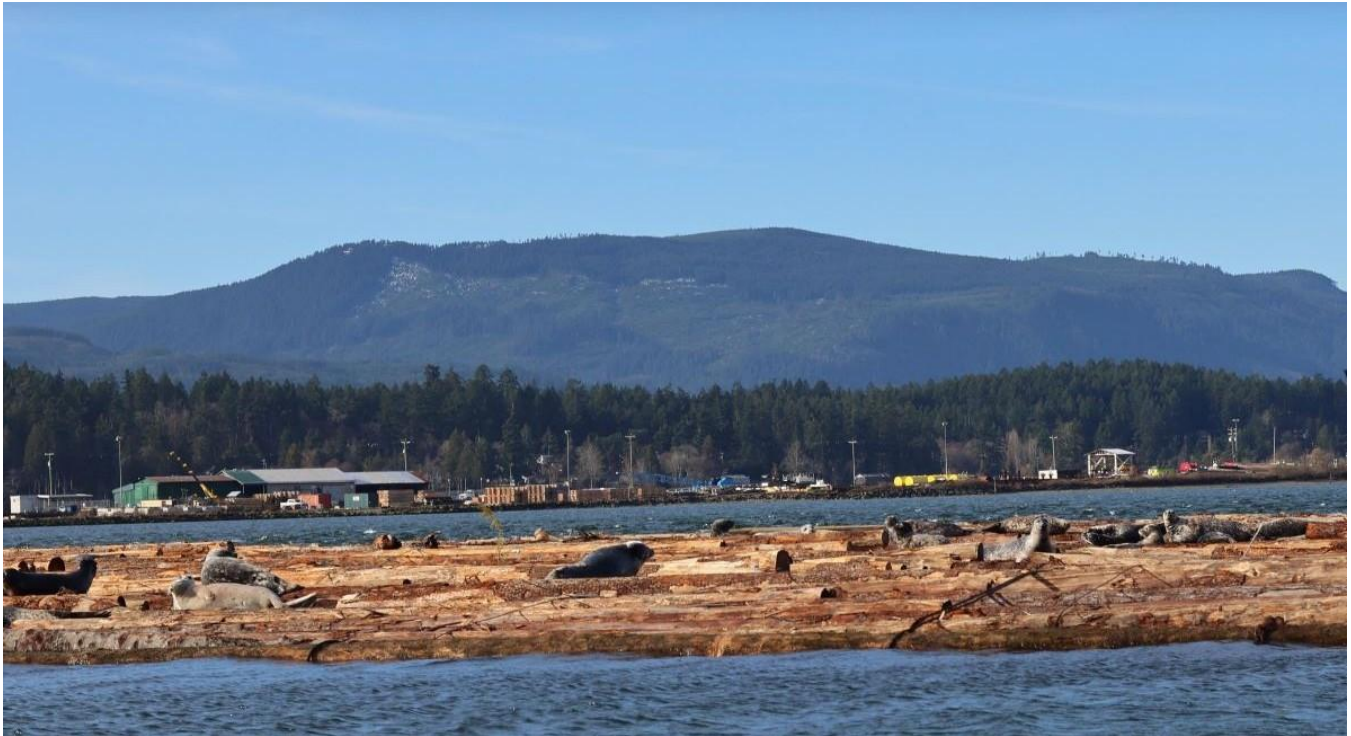
Figure 35 - Harbour seals use a log boom as a haul-out where they can easily hunt Pacific salmon in the Cowichan River Estuary. Photo by Michael Miller Media (Resilient Coasts for Salmon imagery).

One structure of note are the log storage areas or log booms along the coast. It has been documented that seals and other pinnipeds use human-made floating structures such as log booms and docks strategically for hunting salmon (Sabal et al., 2021). In the Cowichan River Estuary, specifically, the

Salish Sea Marine Survival Project (SSMSP) found that the presence of log booms in the Cowichan river estuary was associated with lower survival rates of the Chinook salmon population significantly (Atkinson et al., 2024). The mechanism could be seal predation, habitat fragmentation or altering the natural flow of the river (Sabal et al., 2021) ; however, it is worth noting that pinnipeds were observed in the Resilient Coasts imagery using log booms as haul-outs (Figure 35). Another area that may warrant some additional investigation into the impact of logs booms is the Ladysmith Inlet for its high density of log storage tenures.

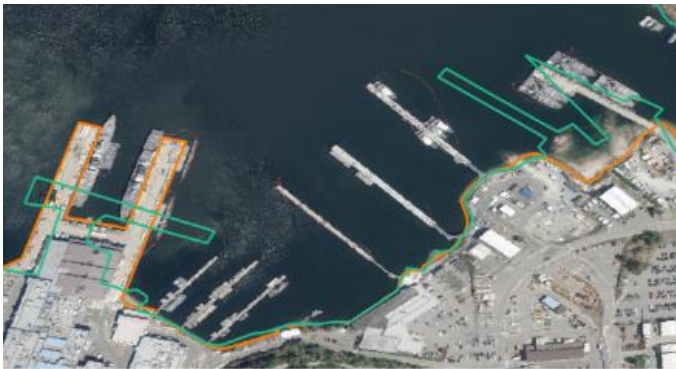
Figure A1 – The FAC dataset (green line) does not align with the digitized feature locations (orange line), which skews results, resulting in an over or underestimation of shoreline length.

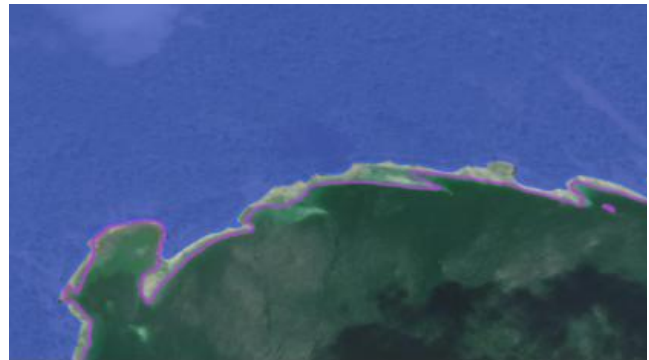
Figure A2 – In some cases, the Federal government First Nation reserve land boundary (shaded blue) was inland of the FAC (purple line).
